# Evaluation of Road Condition Using the Pavement Condition Index (PCI) Method in West Ring Road, Kepanjen District, Malang Regency

Fernando Diotara Mahardika<sup>1</sup>, Henri Siswanto<sup>2</sup>, Pranoto<sup>3</sup>

Civil Engineering, State University of Malang, Jl. Semarang no. 5 Malang, Indonesia, 65145.

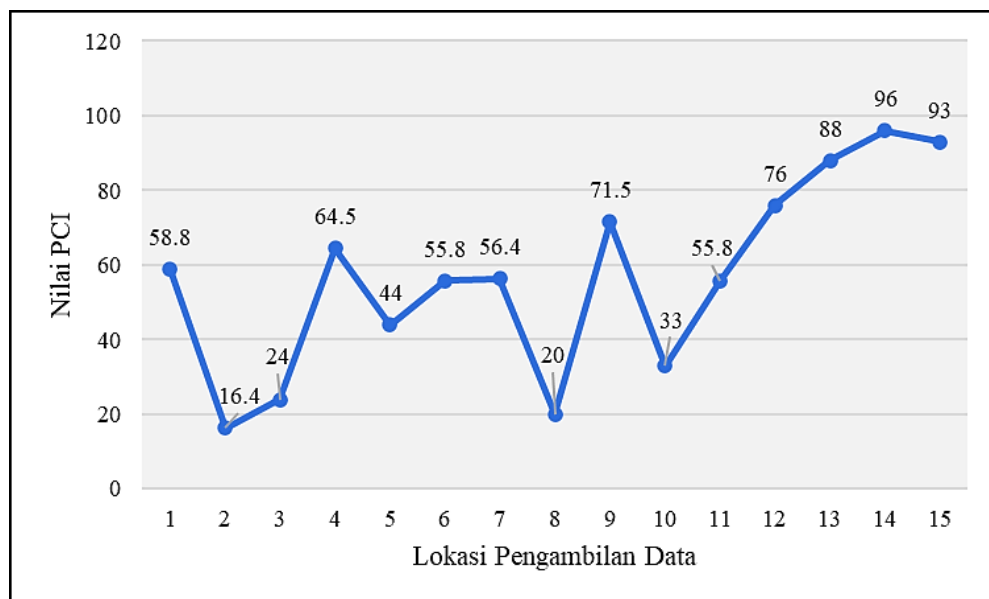
**Figure 1. Road Damage Chart**

From the analysis using the PCI method, the resulting level of road damage in each sample unit and damage to the study location numerically in the form of PCI values. A recapitulation of the PCI value for each sample unit on the West Ring Road of Kepanjen Subdistrict from Malang to Blitar can be seen in Table 4 and Figure 1.

The lowest PCI value on the West Ring Road section is at STA 0+500 – 0+600 which is 16.4 with a serious condition class, while the highest PCI value is at STA 4+100 – 4+200 which is 96 with a good condition class. From the average PCI value of all sample units, the PCI value of the West Ring Road section of Kepanjen District is 56,88 with road damage that is often found in each sample unit including crocodile skin cracks, block cracks, collapse/depression, edge cracks, holes, patches, and grain release. From this value, the West Ring Road section of Kepanjen Subdistrict from Malang to Blitar is categorized as having a moderate level of damage. In the PCI method, the determination of the type of handling must be adjusted to the severity of the road damage that occurs. The type of treatment required can be seen in Table 5.
